Draft Preliminary Geotechnical Engineering Report Piscataway Drive Slope Failure

**Fort Washington, Prince George's County,
Maryland**

May 19, 2014

Subject: Draft Preliminary Geotechnical Engineering Report
Piscataway Drive Slope Failure
Fort Washington, MD, Prince George's County, Maryland
KCI Job. No.: 07100627.W

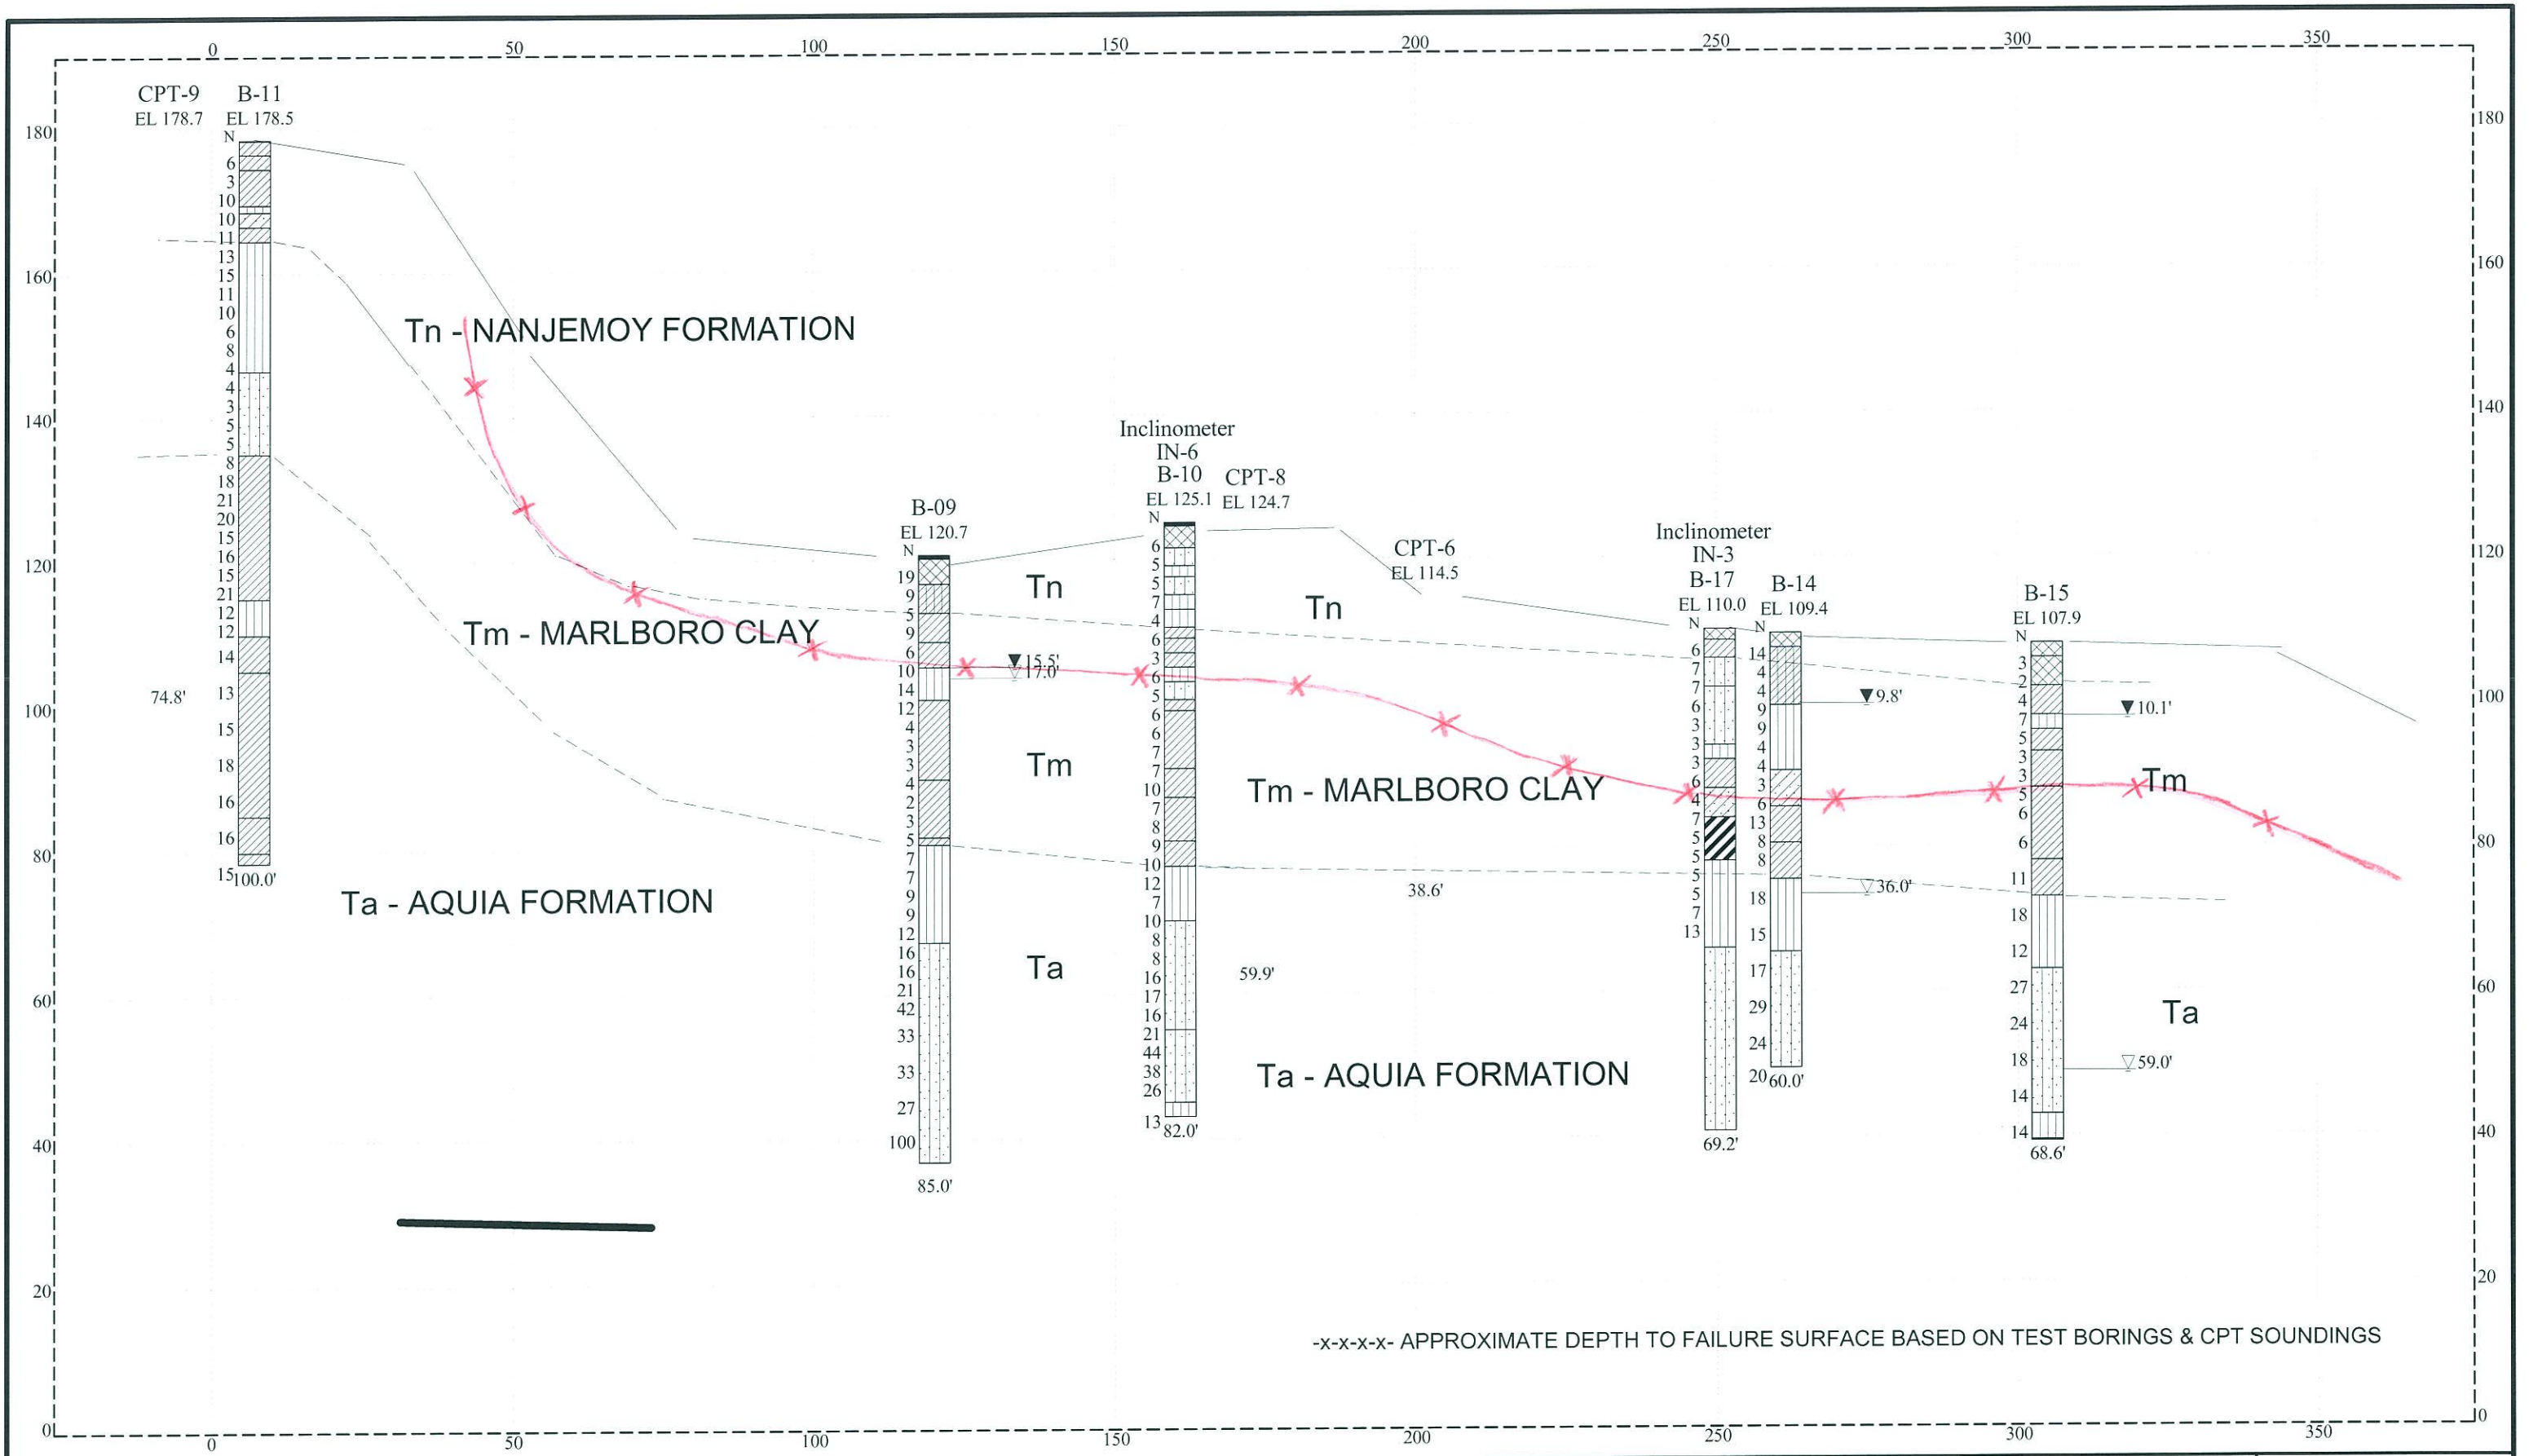
-x-x-x-x- APPROXIMATE DEPTH TO FAILURE SURFACE BASED ON TEST BORINGS & CPT SOUNDINGS

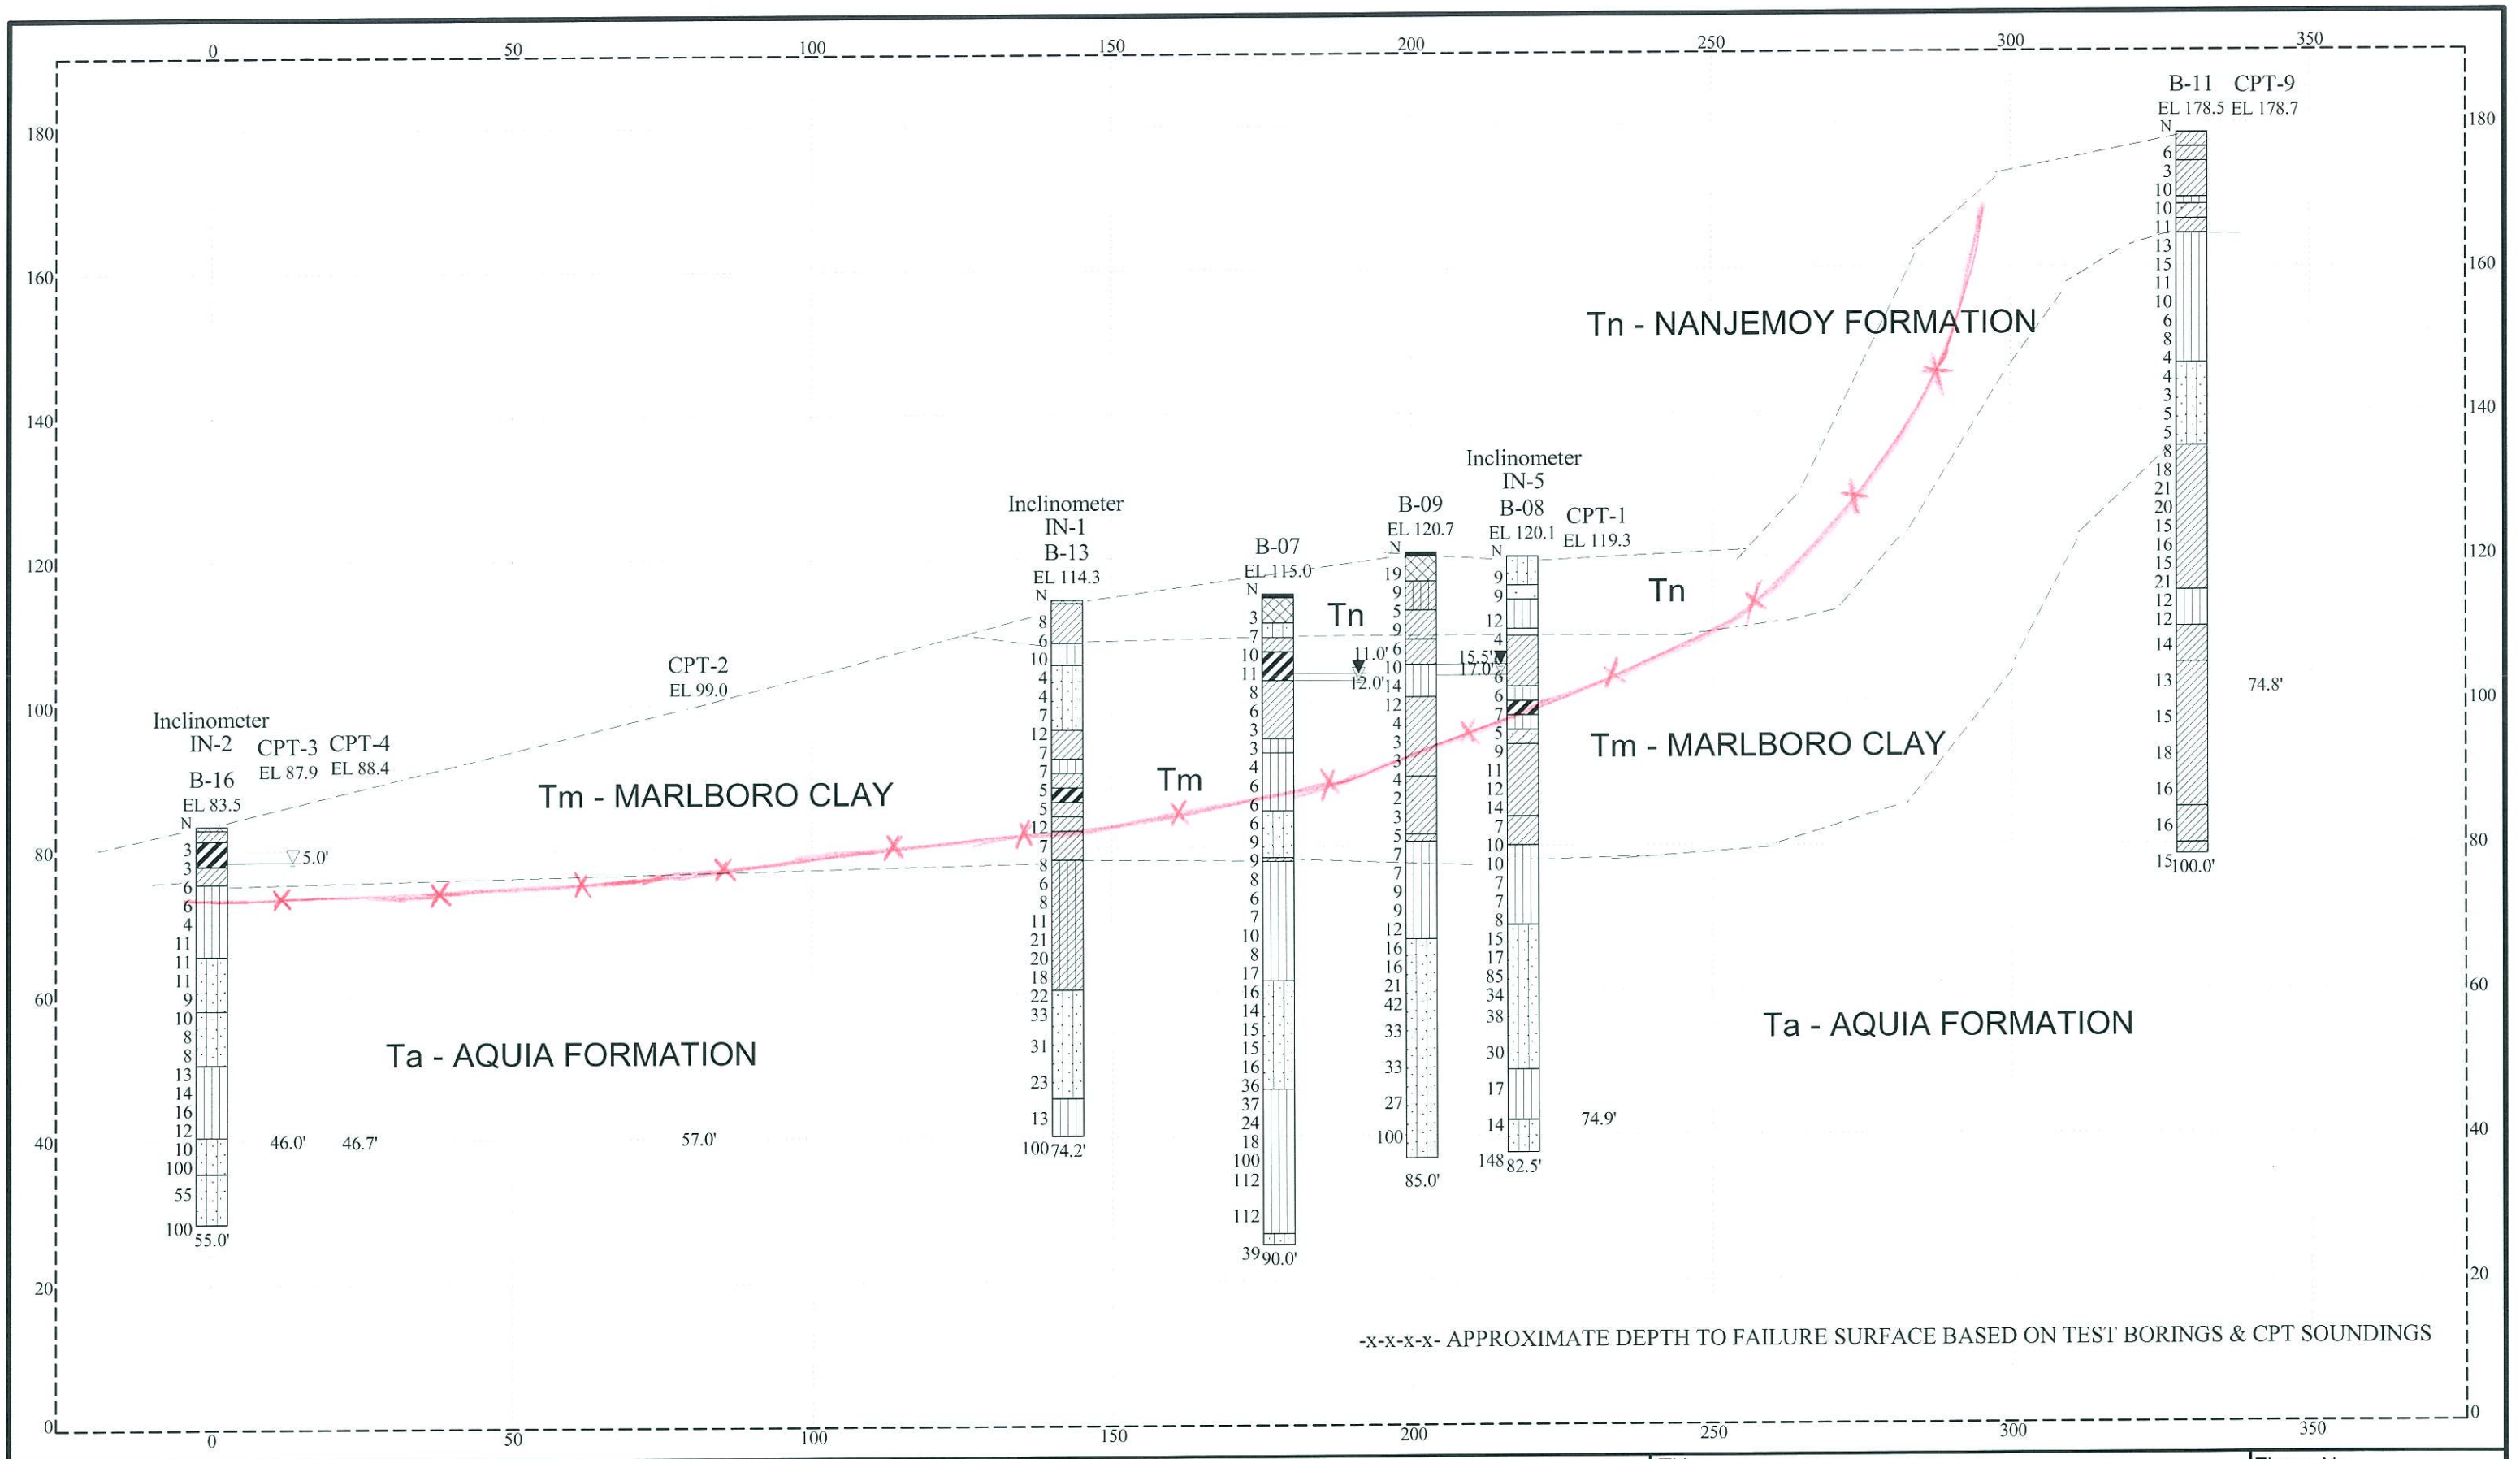
-X-X-X-X- APPROXIMATE DEPTH TO FAILURE SURFACE BASED ON TEST BORINGS & CPT SOUNDINGS

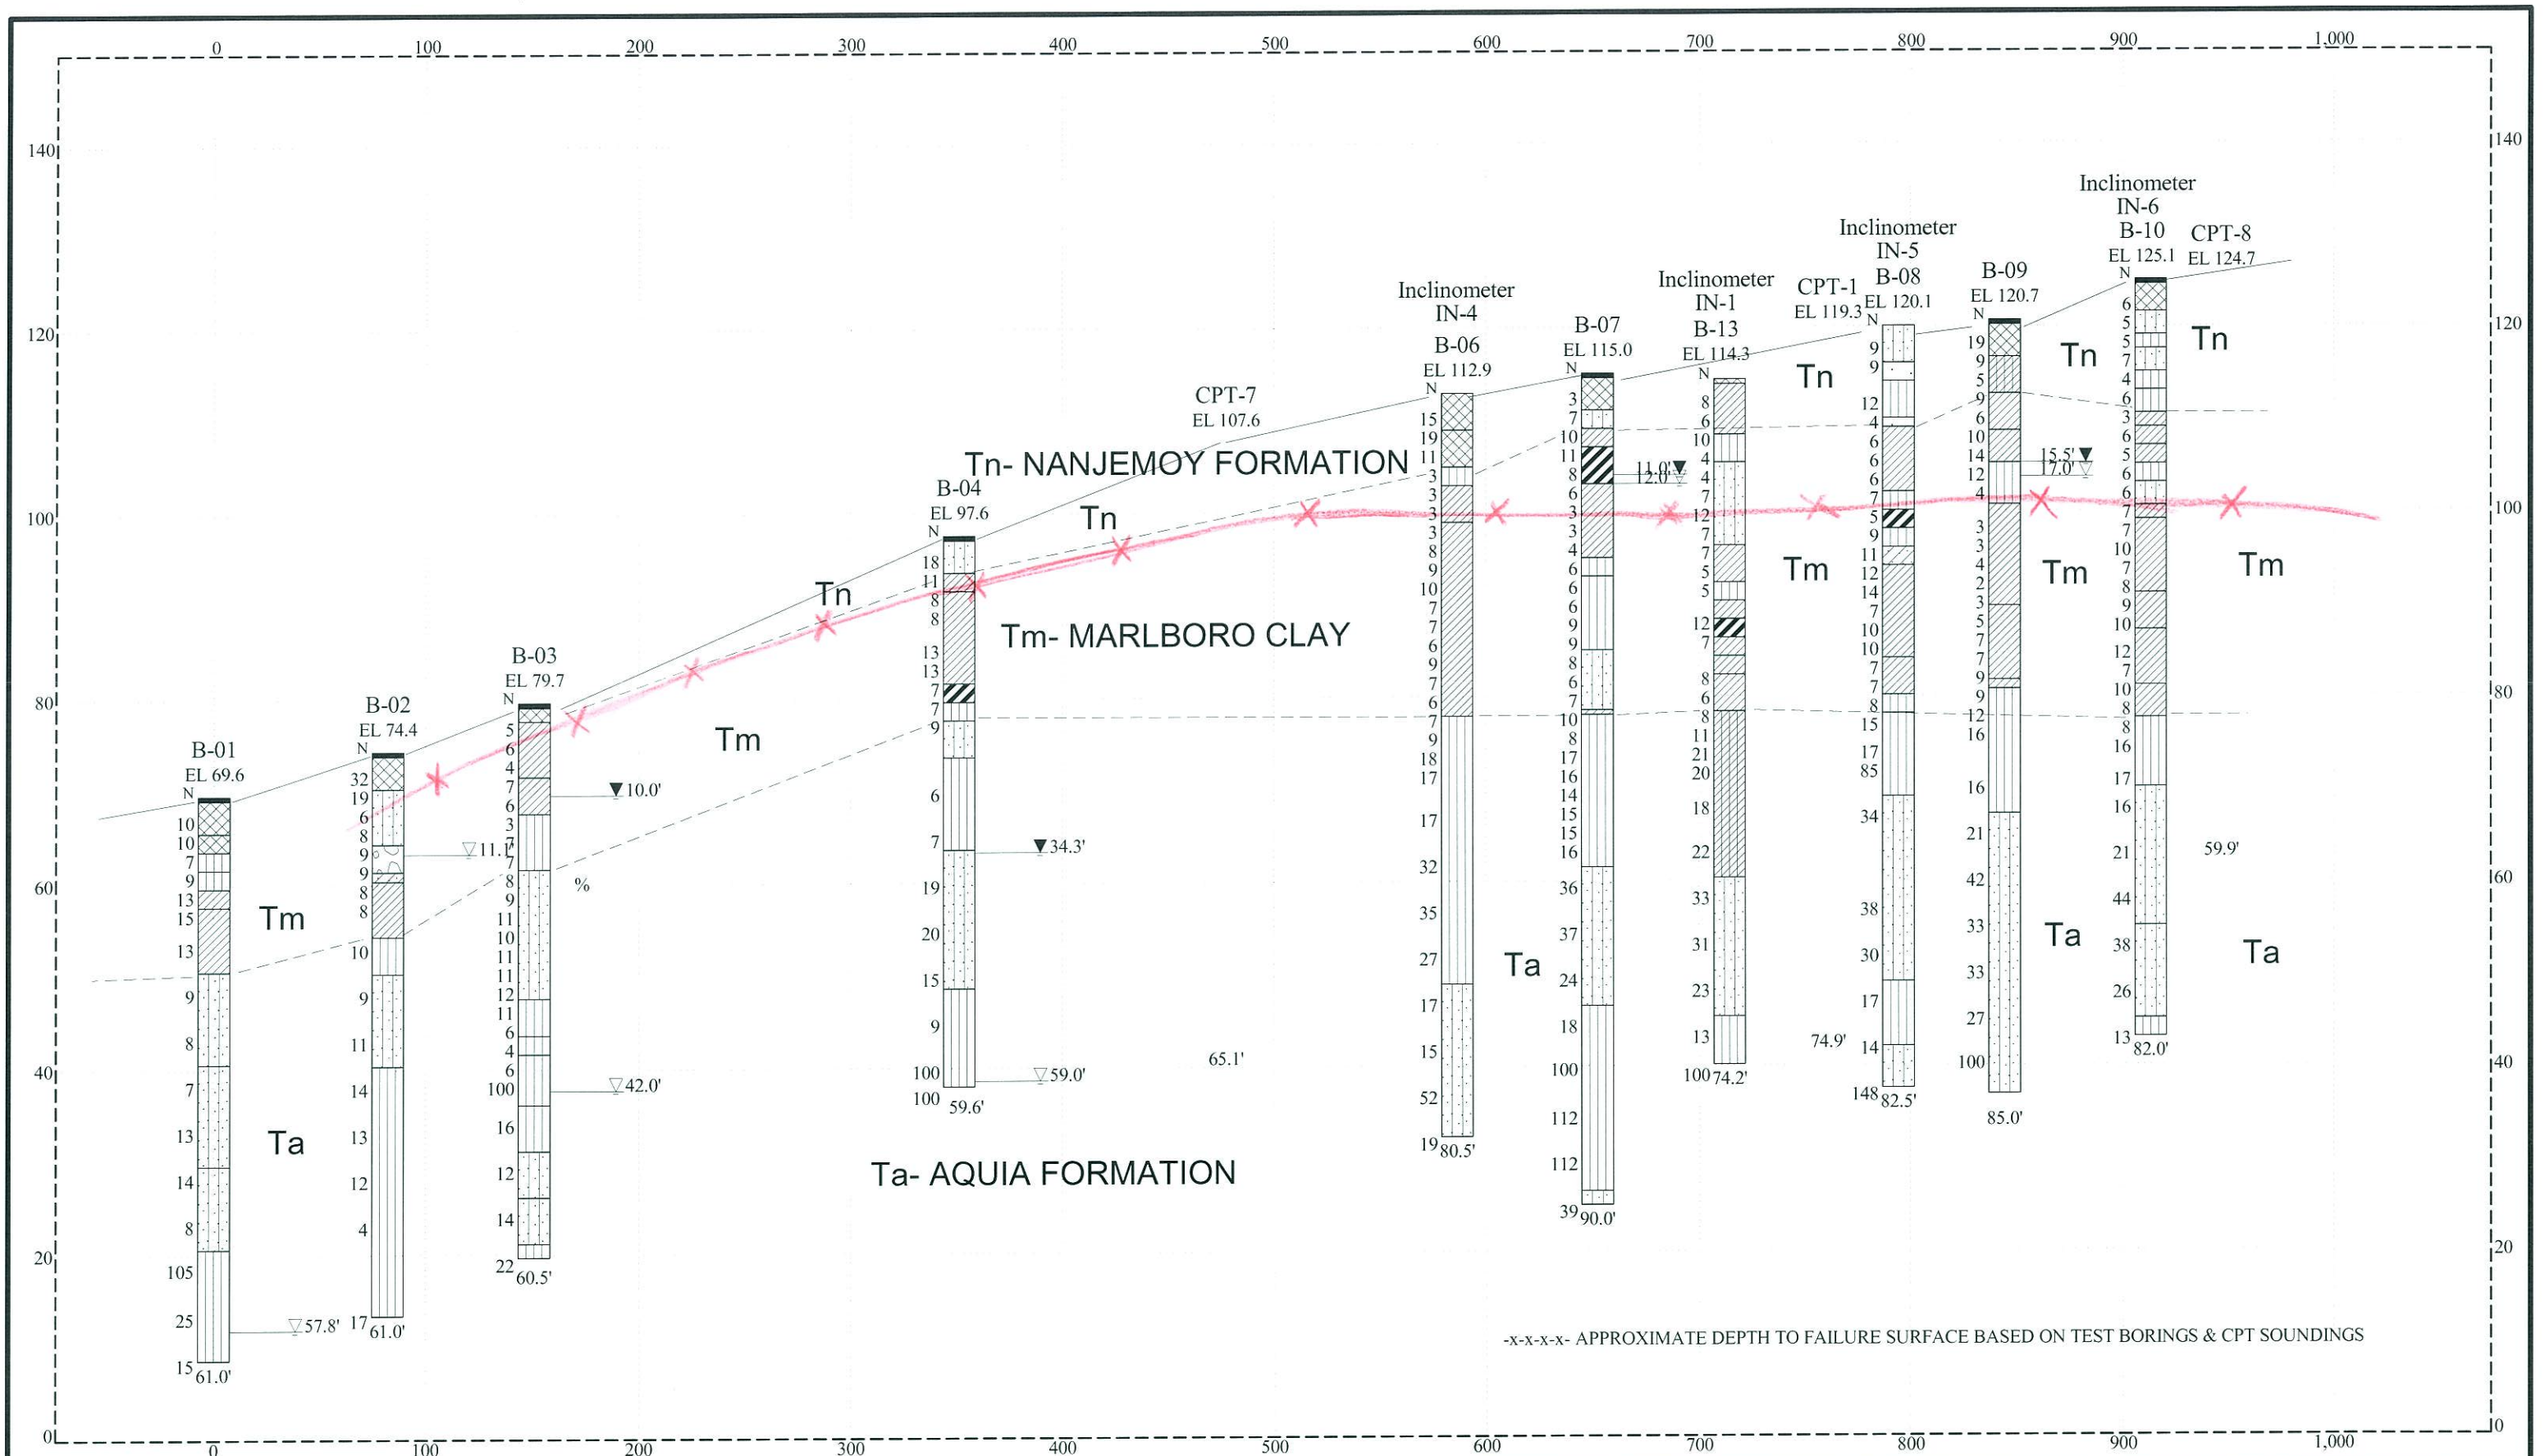
-x-x-x-x- APPROXIMATE DEPTH TO FAILURE SURFACE BASED ON TEST BORINGS & CPT SOUNDINGS
